AGARD REPORT No.729

Impact Damage to Composite Structures.

Reference
IMPROVEMENT OF BATTLE DAMAGE TOLERANCE FOR COMPOSITE STRUCTURES by G.A.Kagerbauer, D.Weisgerber and O.Sensburg	1
IMPACT DAMAGE EFFECTS AND COMPUTATIONAL METHODS by A.Poth and F.Scharpf	2
BALLISTIC SURVIVABILITY CONSIDERATIONS FOR AIRCRAFT STRUCTURES by T.E.Hess	3

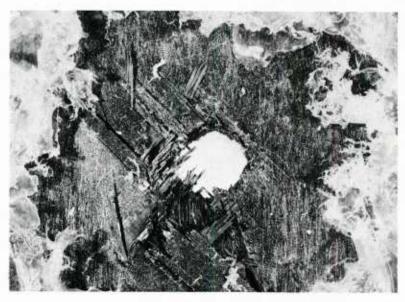
In a further test with the foam filled impact box 30 mm air buffer foil was bonded to the impact plate. The damage caused by a fragment at 1625 m/s is shown in Figures 30 to 32. The impact hole was about 13 mm and delaminations of first plies on the entrance side were about 80 mm long and 40 mm wide. The side of the impact plate showed some delaminations starting at the bolts.

Figure 30: Ballistic impact damage at entrance side (15530) m = 3.5g, v = 1625 m/s, box filled with fibrous foam, air buffer foil bonded to impact plate

Figure 31: Entrance side (15530)

Figure 32: Exit side (15530)

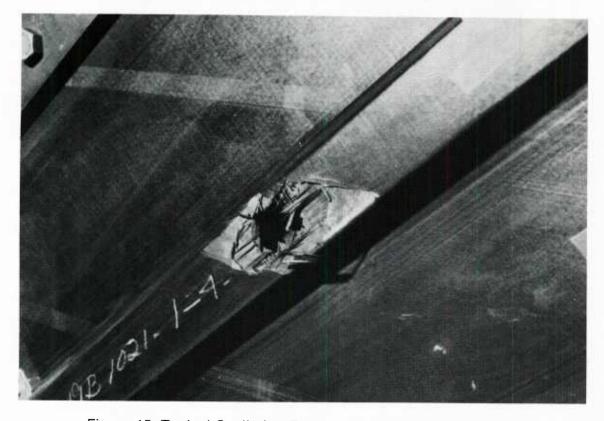
Figure 15. Typical Spallation Damage In Secondary Structures.
